**Flood Control Project Maintenance
Levee Inspections**

Fall 2008 Levee Maintenance Deficiency Summary Report

Reclamation District No. 0150

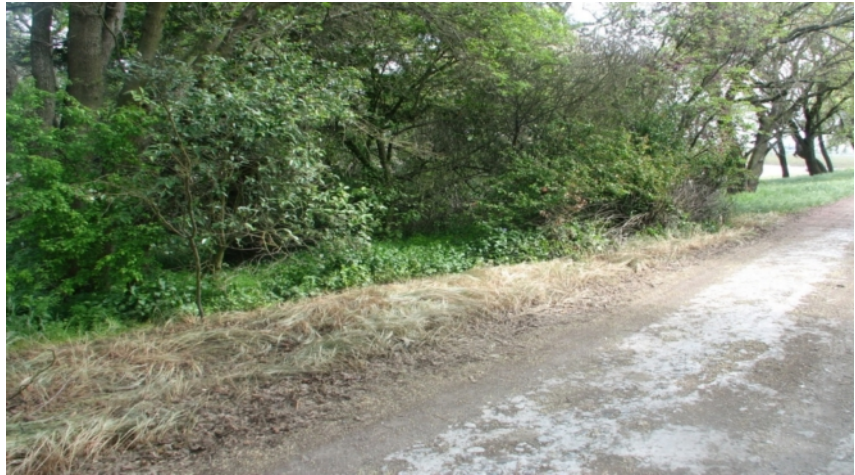
Levee Mile Report Line	38
Start Levee Mile	7.42
End Levee Mile	7.44
Location	
Category	Earthen Levee
Item	Encroachments
Landscaping on landward slope blocking view from LM 7.42 to 7.47

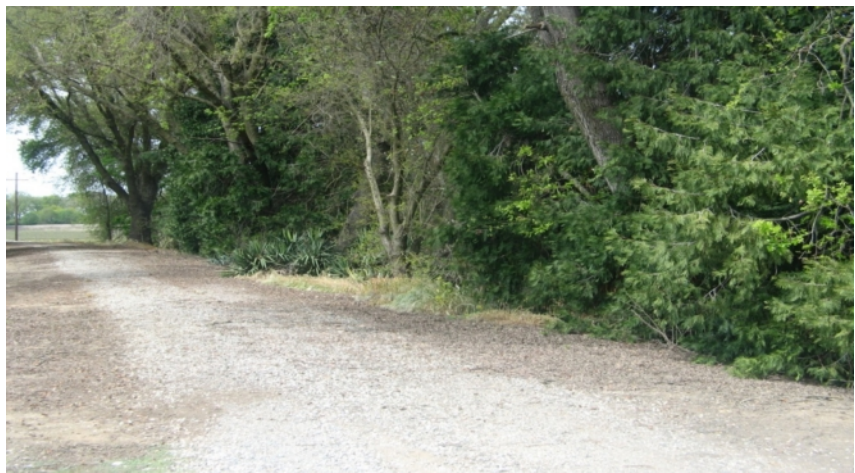
Levee Mile Report Line	41
Start Levee Mile	7.52
End Levee Mile	7.58
Location	
Category	Earthen Levee
Item	Encroachments
Landscaping on landward slope blocking view from LM 7.52 to 7.58

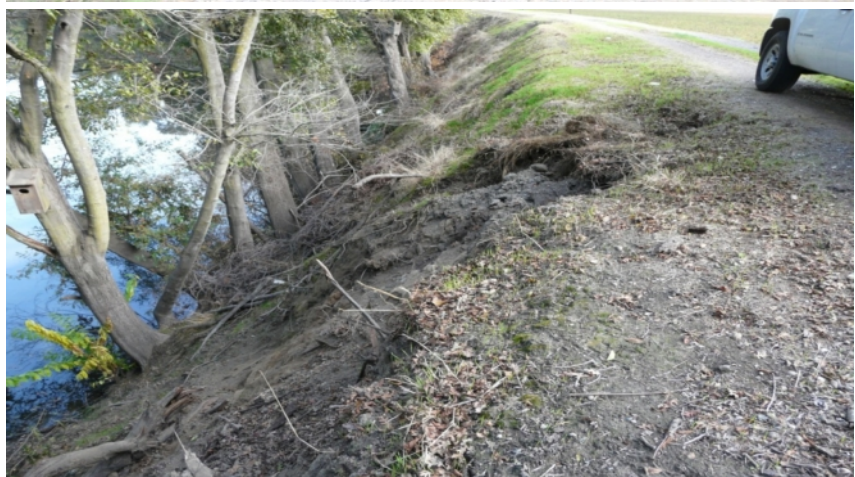
Levee Mile Report Line	43
Start Levee Mile	8.46
End Levee Mile	8.46
Location	
Category	Earthen Levee
Item	Erosion / Bank Caving
Repair erosion on waterward slope near shoulder at LM 8.46.

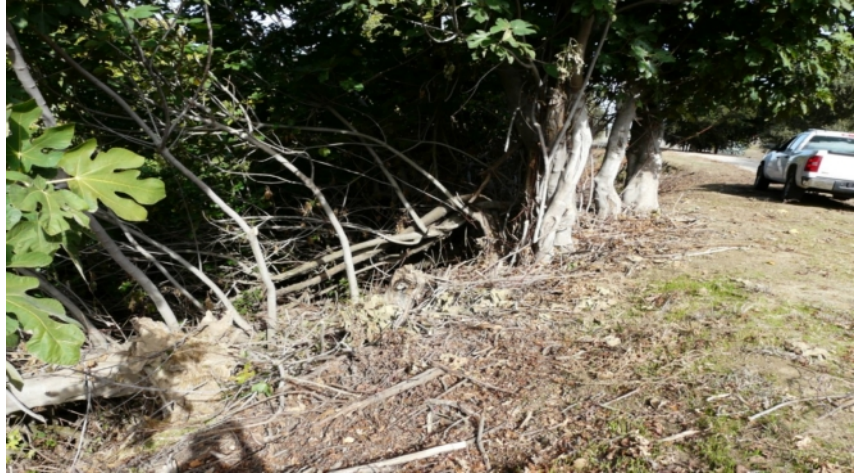
Levee Mile Report Line	51
Start Levee Mile	9.51
End Levee Mile	9.51
Location	
Category	Earthen Levee
Item	Trim / Thin Trees
Thin/trim trees to allow for visibility of top 20' of waterward slope at LM 9.51.
